INDEPENDENT AIRCRAFT ACCIDENT INVESTIGATION COMPILATION

PT. Garuda Indonesia Airways
Boeing 737-400 PK-GZC
Adi Sucipto International Airport 7 March 2007

Compiled By: Gerry Soejatman

THIS COMPILATION IS NOT AN OFFICIAL ACCIDENT INVESTIGATION REPORT

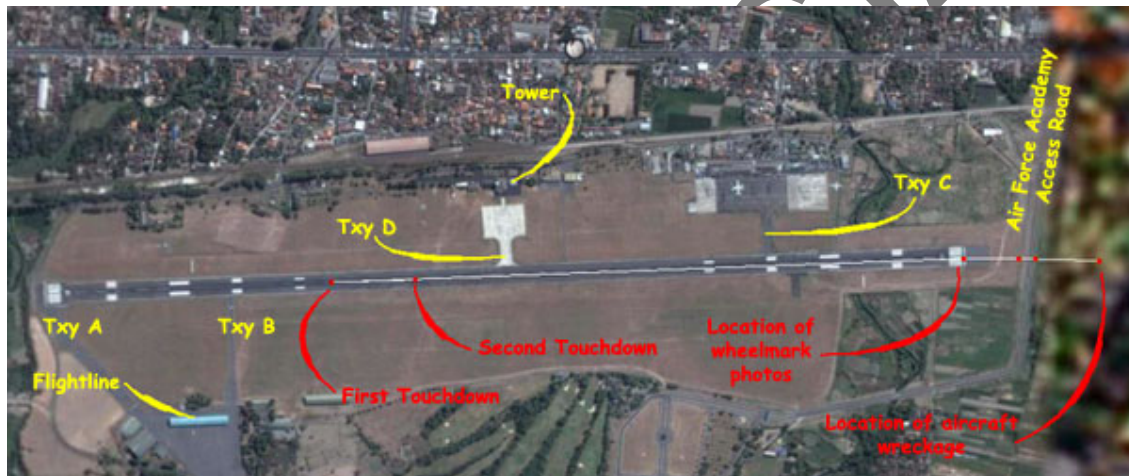
The path of PK-GZC during the landing roll and overrun (Google earth)

Heavy braking marks are evident near the threshold of runway 27 and the nose gear contact imprint continued into the overrun area with a few of the threshold red/green lights knocked from its positions. Imprints continue into the 60 meter paved overrun area, and the remaining 73 meters of clearway.

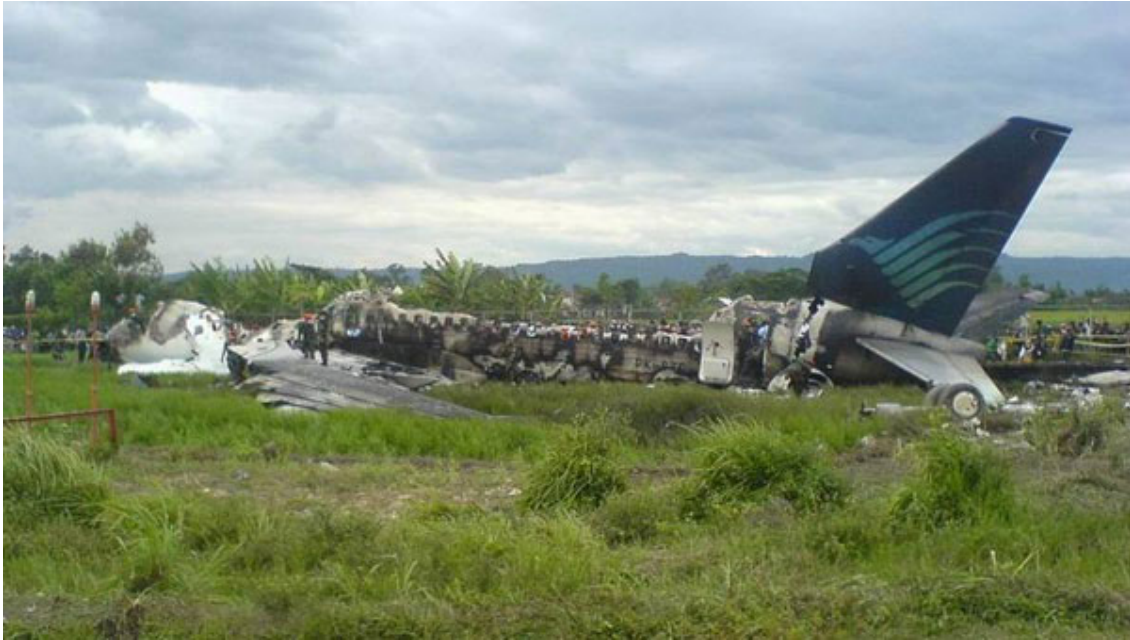
Aircraft destroyed by fire. The tailplane and starboard horizontal stabilizer were charred and no part of the starboard fuselage walls remained in tact. On the left side of the aircraft, fire engulfed the fuselage to the cabin window level from the top. The right wing outboard of the engine mounting had rested on top of the left wing facing 135 degrees from the direction of the aircraft. All landing gears were detached and both engines were detached.

Fire had destroyed most of the fuselage (detik.com)

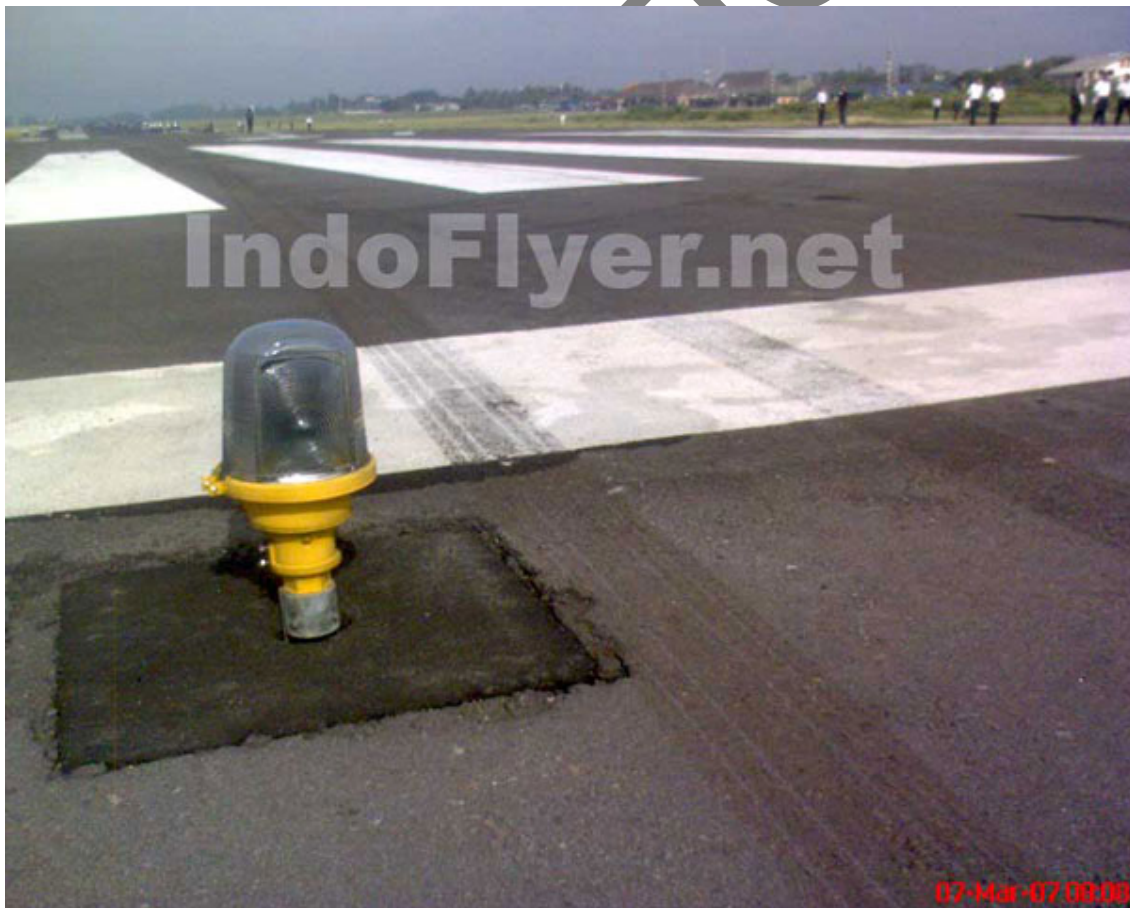
Heavy Braking Marks (*indoflyer.net*)

However, it remains unclear when did the heavy braking started during the landing roll except that it has been reported to have started only a few hundred meters from the end of the runway.

Wheel brakes of the aircraft had malfunctioned the day before the flight but the brakes have been replaced and are deemed not a factor to this accident. Max manual brakes appeared to have been applied by the flight crew based on photographic evidence showing the wheel marks which have been stated by some sources as "consistent with heavy manual braking."

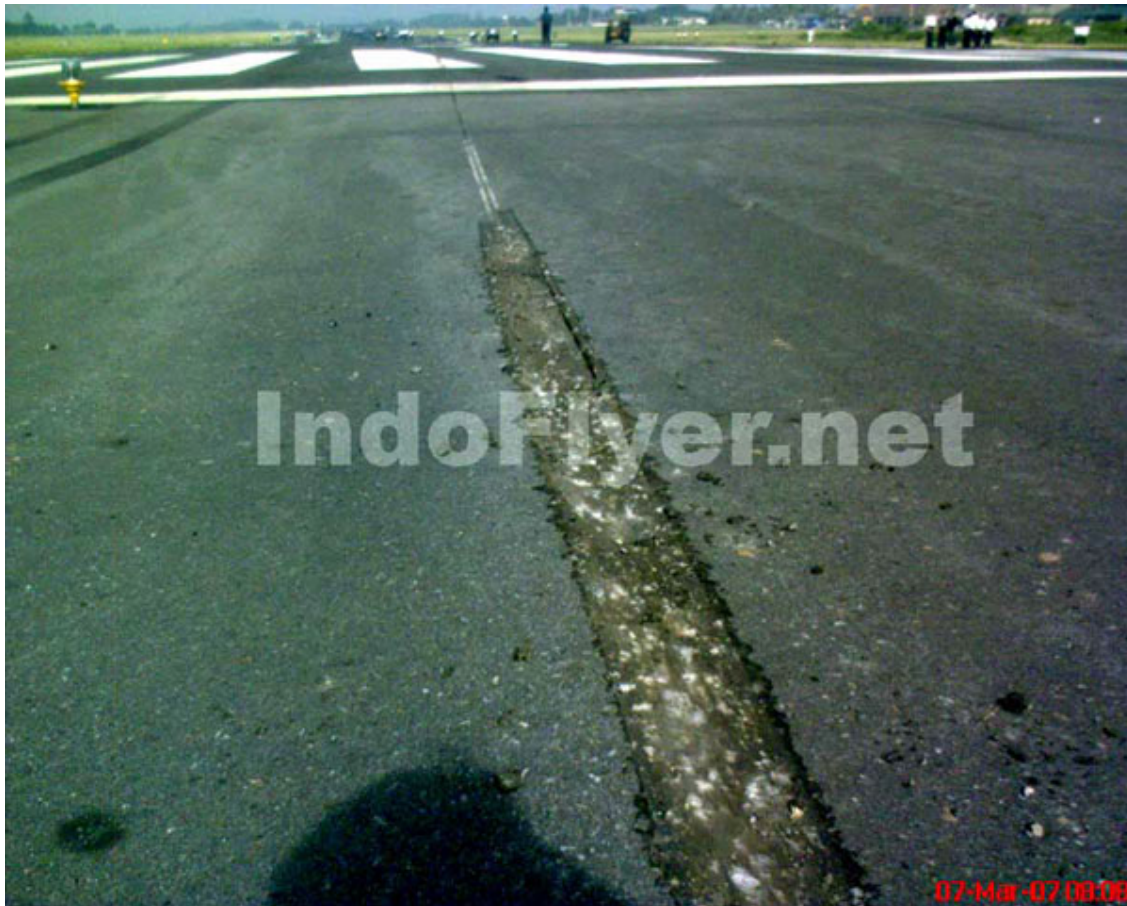
Nose gear rim ground contact (*indoflyer.net*)

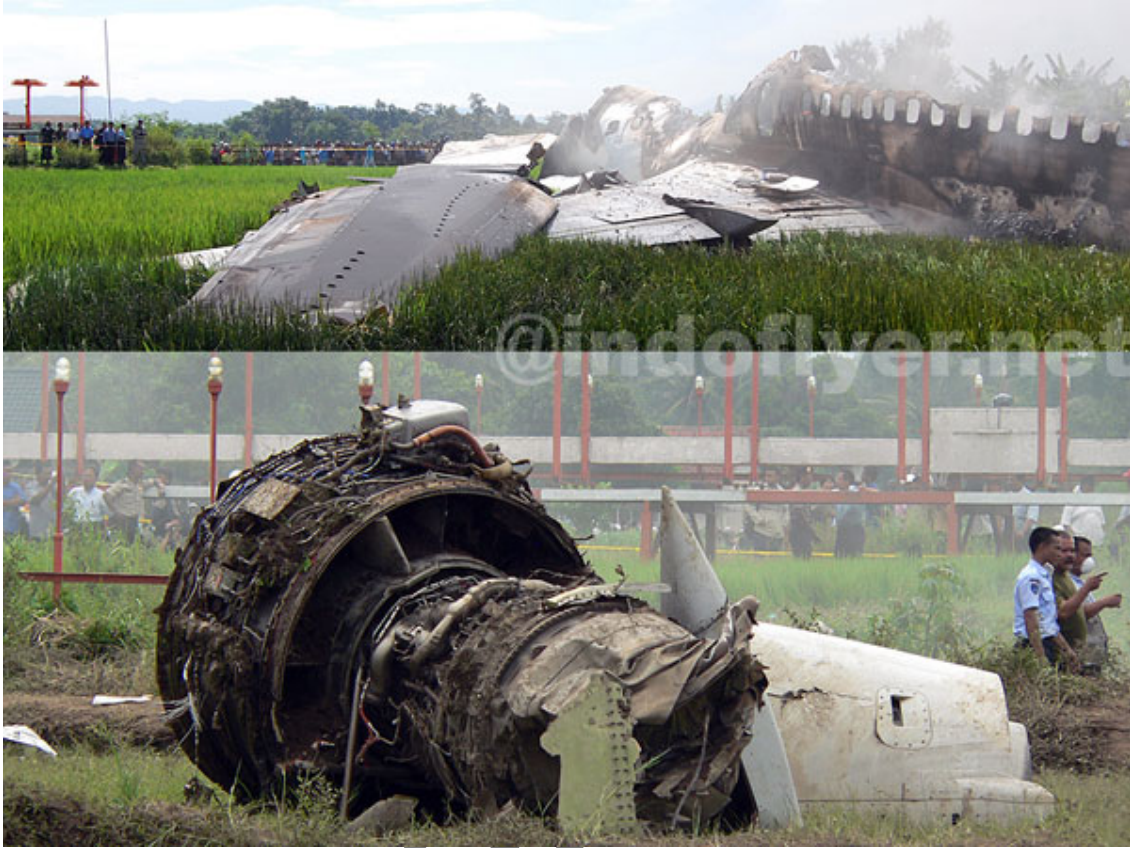
One engine was found without its cowlings detached to the left of the aircraft with parts of the cowling and a flap fairing. This engine also had impact marks on the rear where the exhaust was crumpled.

Although the right wing outboard of the right engine had ended up resting on top of the left wing, based on photographic evidence, it is found that the flaps were not in normal position for landing. The

trailing edge flaps were found to be deployed around the 15 degrees based on photographic estimates.

Right wing on top of left wing and a detached engine (*indoflyer.net*)

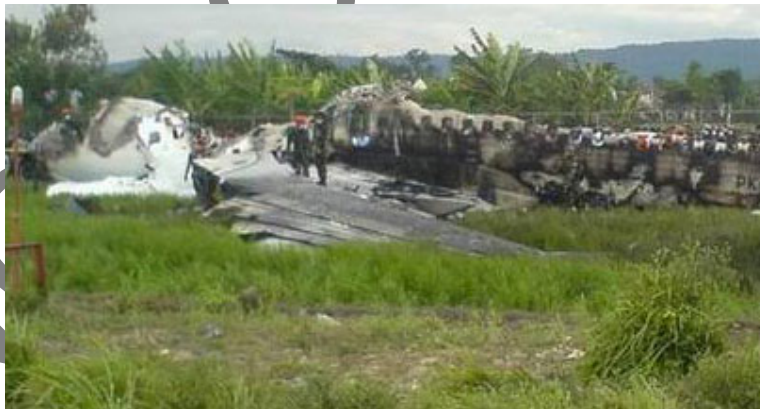
Left wing flaps (*detik.com*)

- VI. The flaps were found to be between 15 degrees and 30 degrees, instead of the normal 30 degrees as per Garuda's SOP.
- VII. It was more than possible for the crew to have completed the items required by the QRH upon identifying the problem.
- VIII. Traffic may have been a factor for the flight crew's reluctance to go around.
- IX. Visual misperception/difficulties may exist despite the reported good visibility by the airport.
- X. No evidence of mishandling of the accident by the airport as delays was caused by the geography between the airport's perimeter and the aircraft wreckage.
- XI. No evidence of negligence on behalf of the cabin crew for not deploying the slides and for not using the front left emergency exit.

Emphasize on the hazards involving abnormal landing configurations and the need for the correct landing technique in those situations with flaps less than normal landing flaps. Assess the documentation on flight crew procedures in the event of an unstable approach in a flap asymmetry or trailing edge flap disagreement for flap positions beyond 15 degrees.

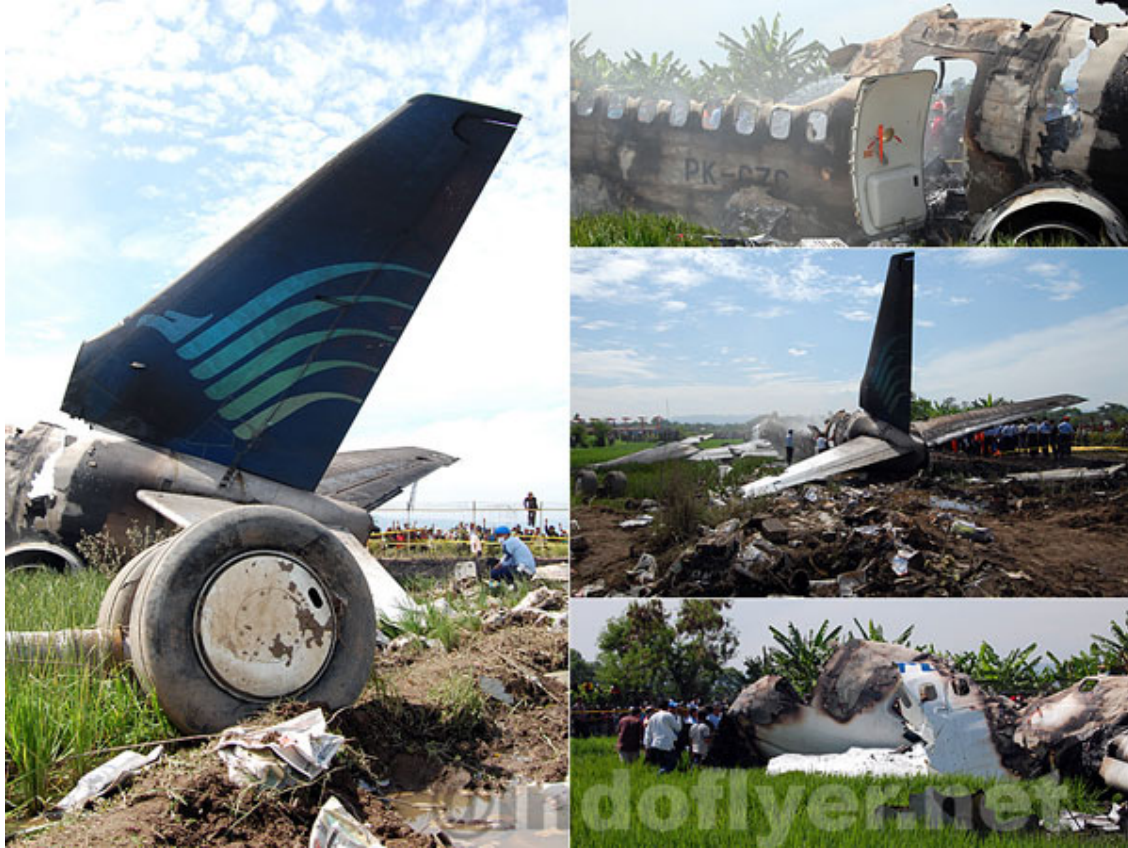
The wreckage (*indoflyer.net*)

Door L1 was unusable due to its position after impact. No exits on the right hand side were used due to fire. The left emergency exit windows and rear door on the left were used for evacuation. The slide on the rear left was not used for evacuation, although the "slide armed" tape is still attached to the door. This indicates that the crew had checked the conditions outside of the door prior to opening, and that the risk of fire and the height above the ground would have deemed slide deployment as a hindrance.
