INDEPENDENT AIRCRAFT ACCIDENT INVESTIGATION COMPILATION

PT. Garuda Indonesia Airways
Boeing 737-400 PK-GZC
Adi Sucipto International Airport 7 March 2007

Compiled By: Gerry Soejatman

THIS COMPILATION IS NOT AN OFFICIAL ACCIDENT INVESTIGATION REPORT

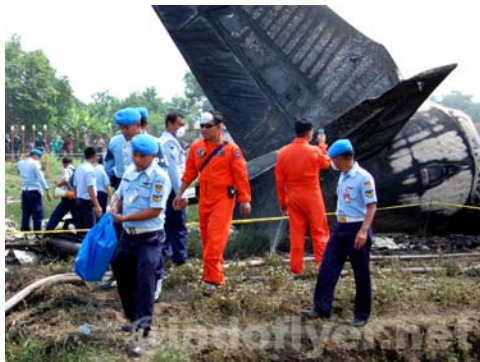
Photo of the flight recorders being removed from the site (*indoflyer.net*)

The airplane was equipped with a cockpit voice recorder (CVR) and a flight data recorder (FDR). The recorders were secured and quarantined on the day of the accident and then sent to the Australian Transportation Safety Board (ATSB) for download and readout. The CVR was unable to be downloaded in Australia and has been sent to Honeywell in the United States due to damage caused preventing it to be read in Australia.
